DAVIDSON & ASSOCIATES

1750 Tysons 2 McLean VA. Property Condition Assessment

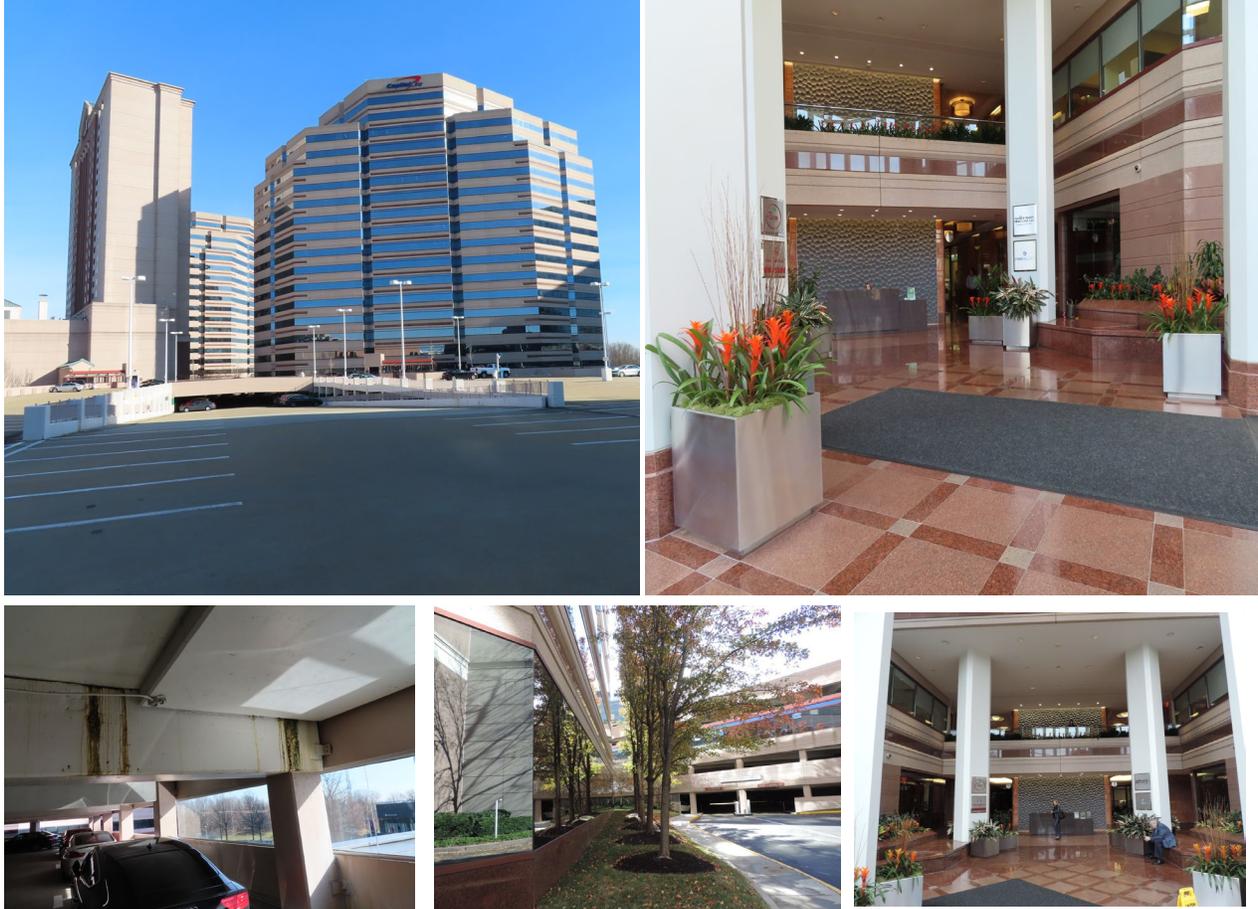
Value Added: Davidson & Associates review of the property identified: that although the building is being generally well maintained, due to the age of the building, several of the components will need replacement or repairs with the next few years, including: roofing, sealant, window gaskets, and mechanical equipment. D&A also identified repairs required at the parking structure, including sealant, expansion joints and stair tower enclosures.
