## 5012 Hampden Lane Forensic Investigation, Design Repairs & Quality Assurance during Construction

Cracks developed in the concrete foundation wall of a single-family residence under construction, resulting in leaks and substantial inward bowing of the wall. The house is located in Bethesda, MD.

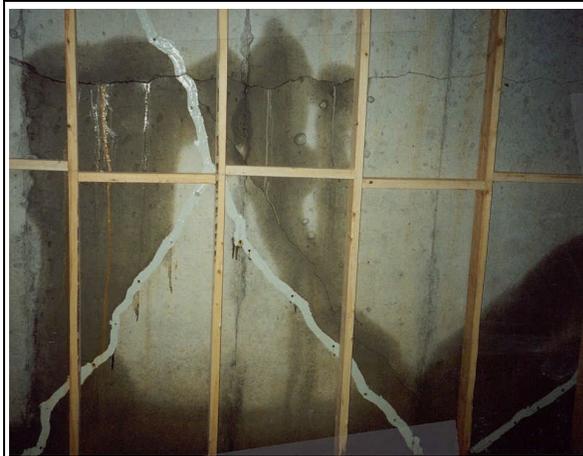
Un-repaired cracked foundation wall. Water infiltration, visible at cracks.

**Value Added:** Davidson & Associates determined that premature backfilling compounded by insufficient strength concrete and a lack of vertical reinforcing steel caused the cracking. Structural repairs were designed by D&A to include urethane grout injection of the cracks to mitigate water infiltration, then epoxy grouting a reinforcing steel grid to the existing foundation and foundation wall and installing a shotcrete overlay.
