Cathedral Avenue Condominium Forensic Investigation, Design Repairs & Quality Assurance During Repairs

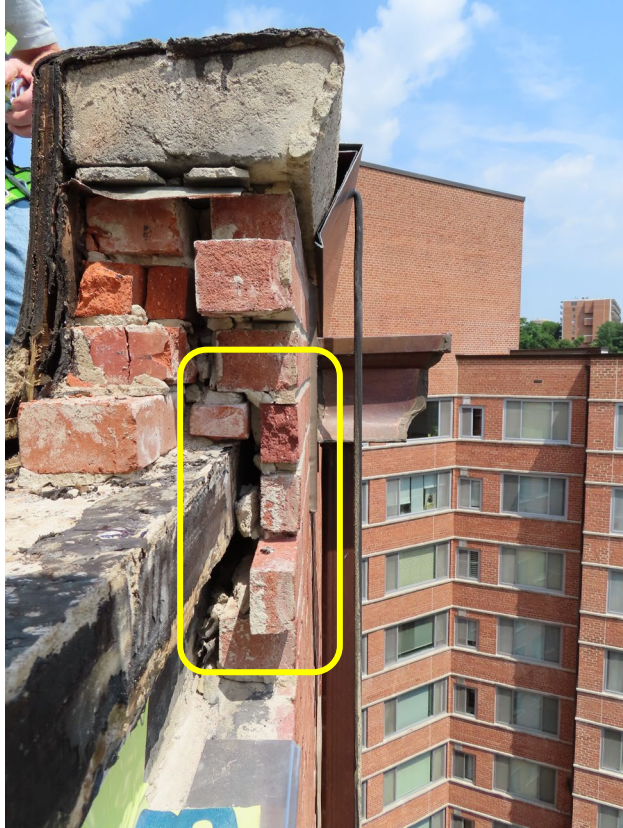
Unstable Parapet

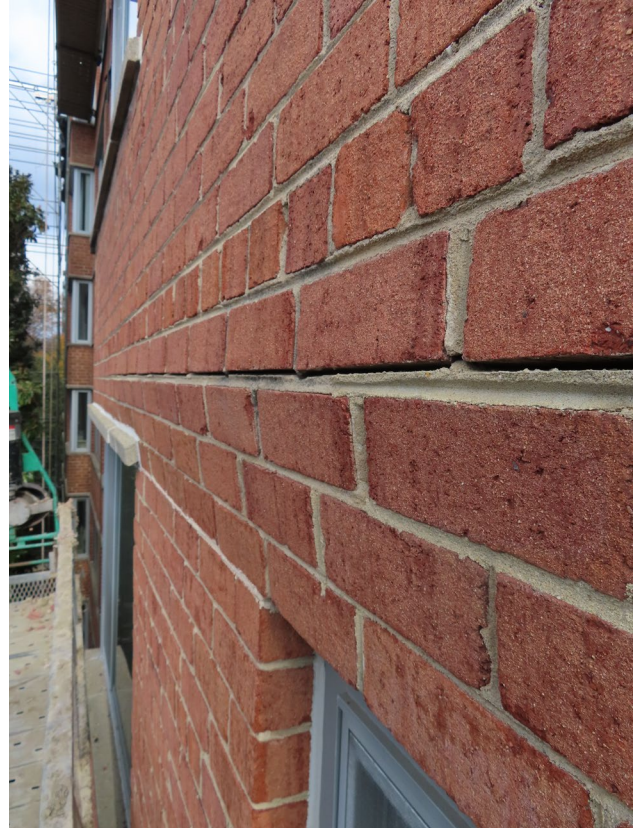
Masonry Lifting and Cracking After Tuckpointing

- Defective Remedial Design: The movement in the masonry at the bulges formed cracks in the mortar horizontal joints resulting in water infiltration. A full façade restoration project was performed in 1998. The remedial design was deficient by not including a solution for eliminating the vertical stress. Instead, mortar joints were tuckpointed in an attempt to prevent water infiltration through the existing cracks. This tuckpointing reintroduced the vertical stress, which increased the cracking at the masonry. See top right photo.

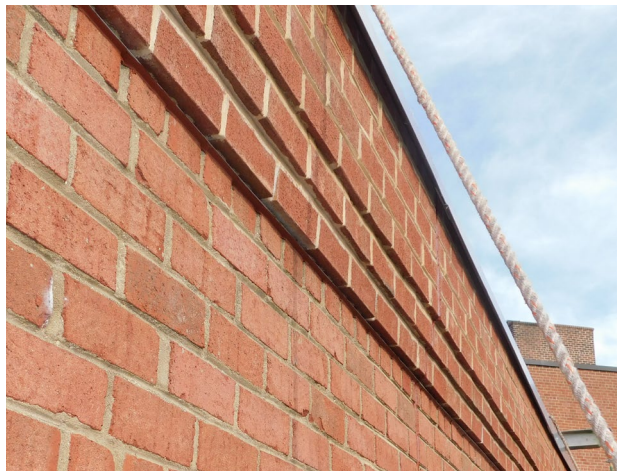
Accent Double Corbel Parapet for Clearance

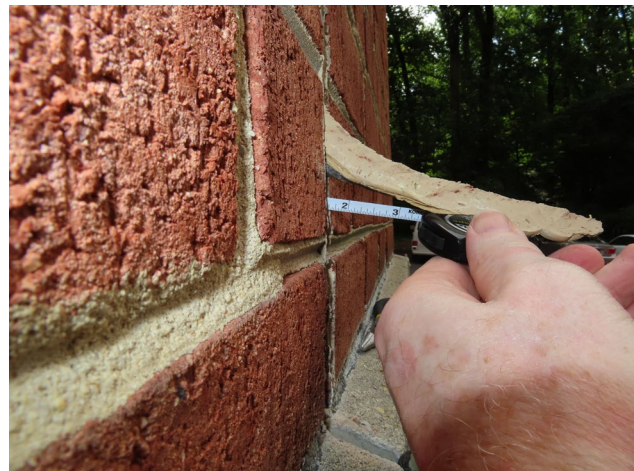
1998 Resto, Superficial Expansion Joints 2" into 4" Brick

- Defective Remedial Workmanship: The 1998 program included installing vertical expansion joints to relieve horizontal stress. During D&A’s analysis, stress crack patterns consistent with horizontal stress was documented. Further investigation, including borescope analysis, revealed at all locations tested, that the vertical expansion joints – which must be cut through the full 4” depth of the brick – were superficial and only extended up to 2” into the brickwork, which does not relieve any of the stress. This is consistent with the work being performed much cheaper with a lightweight grinder instead of the more suitable and substantial masonry saw.
