South River Condominium Forensic Investigation, Design Repairs & Quality Assurance During Repairs

INNOVATIVE METHOD ELIMINATES BRICK REMOVAL FOR VERTICAL REPAIRS

ALTERNATE REMEDIAL DESIGN REDUCED PROJECT COST BY 30%.

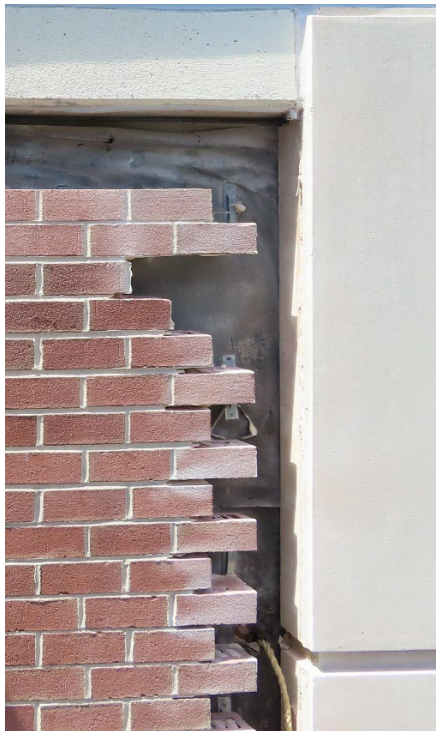
OVERVIEW OF TYPICAL WALL ELEVATION DISPLAYING VERTICAL TOOTHING OF BRICK

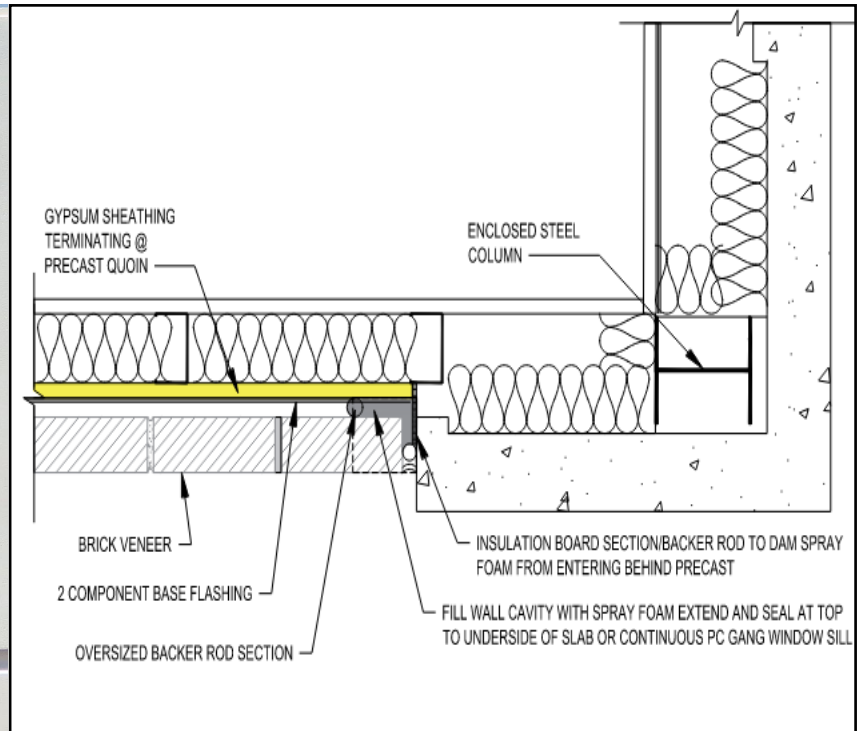
CONVENTIONAL VERTICAL BRICK TOOTHING

- Conventional Remedial Design Mockup: The entire façade of a top floor unit with water infiltration at multiple conditions was selected for mockup and water testing to determine constructability, effectiveness, and projected costs. The standard/conventional method required removing large amounts of adjacent brick in a toothed pattern to install a vertical separation between the two wall assemblies and jamb of all windows and balcony doors. This vertical separation consisted of backer rod with a 4" wide foam sealant dam extending to the infiltration source or termination of the sheathing (Ex. window/door jamb and precast). This method was more difficult than anticipated as existing mortar droppings often clogged the drainage cavity preventing ease of access for the backer rod to be positioned which led to the removal of additional brickwork. See top and bottom left photos. This work effort, cost, and disruption to residents was disproportionately high compared to the other work and the patches objectively visible.
