College Park Towers Forensic investigation and Design of replacement balconies & Quality Assurance during Construction

Service performed: Limited initial observation; analysis of engineering study; design of repairs; Quality Assurance during Construction.

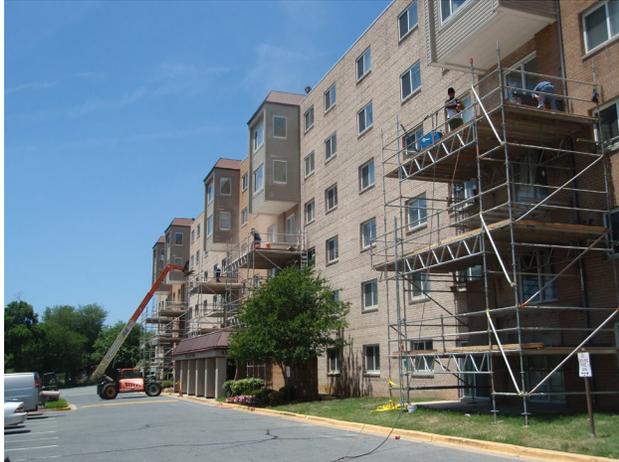
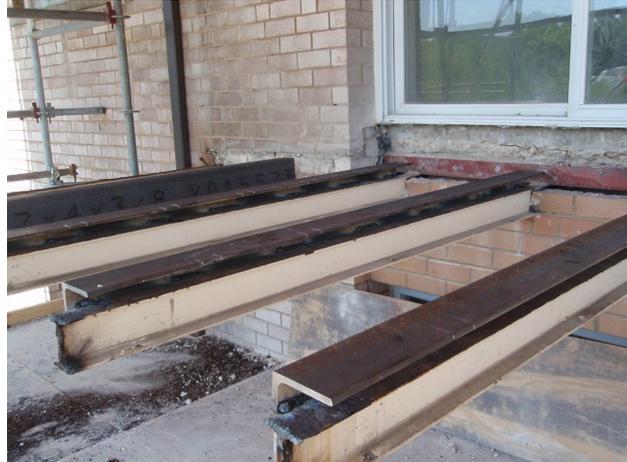
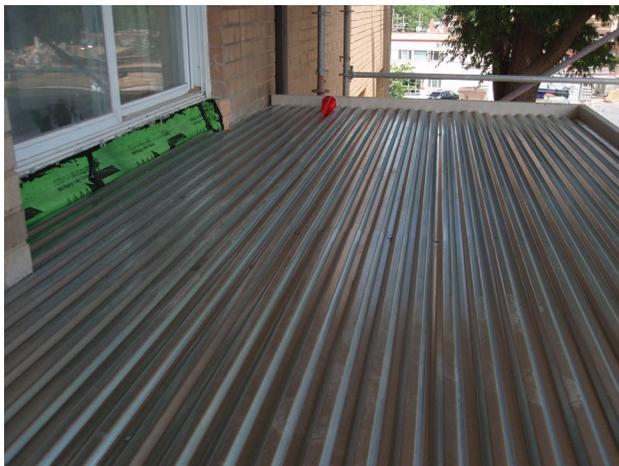
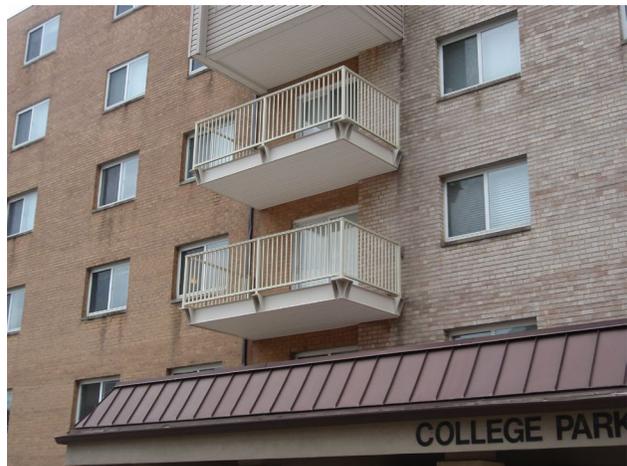
Description: The cantilevered balconies consisted of small cantilevered beams supporting metal pans and concrete pads with steel perimeter beams and steel railings. The condition of the railings and steel framing varied from fair to poor condition and replacement was required. D&A designed reinforcement for the steel beams and replacement of the concrete decks, perimeter beams and railings, plus a waterproof deck coating to protect the steel.

Value Added: Davidson initially performed a limited review of the property and found that the structural condition of the balcony framing and guard varied widely and recommended further study. This was performed and structural repairs were recommended. D&A worked with the Structural Engineer to maintain the existing beams, but reinforce them to accommodate the current loading conditions for a balcony.
