## Skyline Tower Apartments Exterior Restoration – Design & Construction Phase Services

Eight story art deco style apartment building constructed in the 1930's. Exterior consists of multi-colored brick veneer in a variety of bond patterns with structural clay (speed) tile backup supported on concrete frame. New, aluminum frame, thermal break windows installed in 2004 bridging the original steel frame window heads, jambs and sills. Roofing system consisting of modified bitumen membrane over rigid insulation and protected by stone ballast replaced circa 1985. The project is located in Washington, DC.

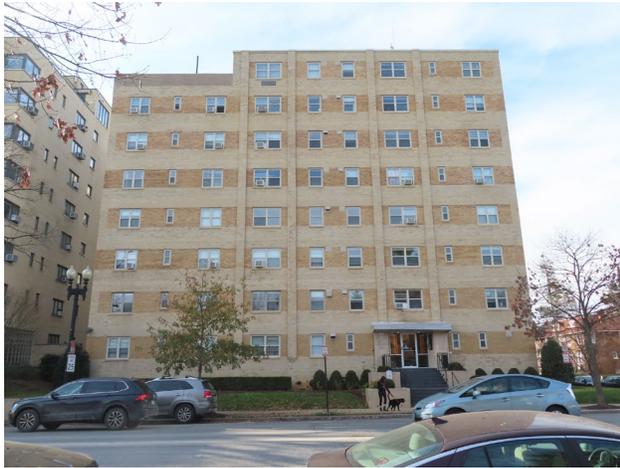
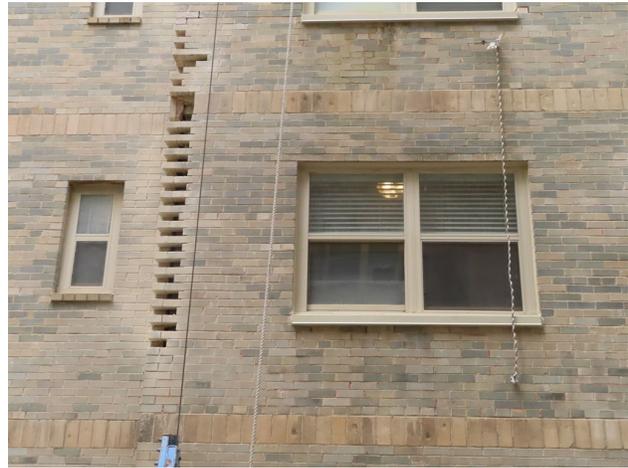
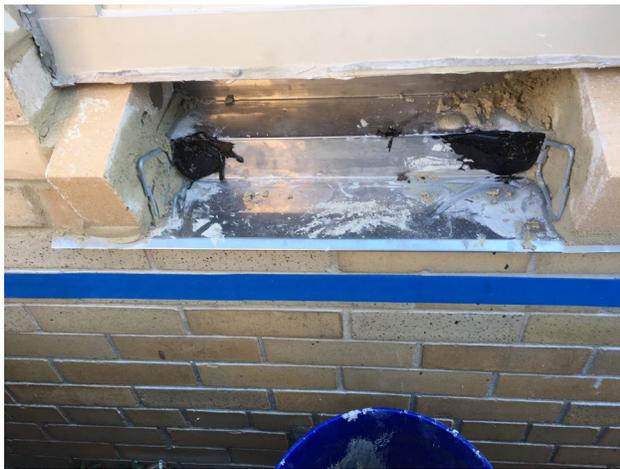
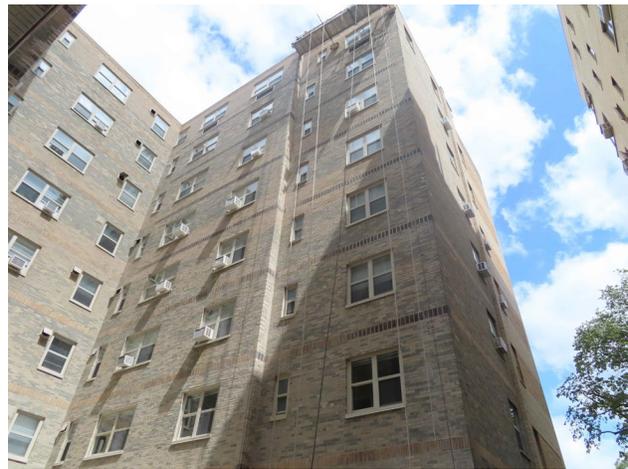
**Value Added:** D&A's prior forensic analysis identified causes of and proposed repairs for addressing ongoing water intrusion. D&A's façade restoration experience identified cost-effective methods to re-establish water resistance and structural integrity of deteriorated masonry including: selective mortar repointing/collar joint grouting; crack stitching/repair; introduction of brick expansion joints to minimize future cracking; window sill reconstruction with stainless steel flashing pans at primary facades; capping of sills at secondary facades; sealant. louver and coping replacement.
