DAVIDSON & ASSOCIATES

CONSTRUCTION ANALYSTS, INC.

Towson Woods Apartments Railing Inspection and Quality Assurance during Construction

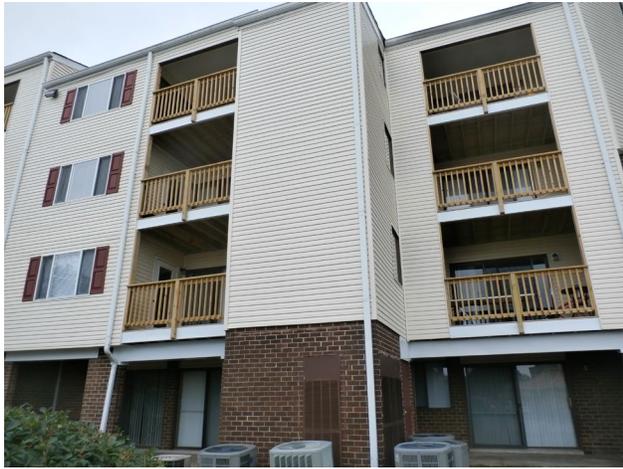
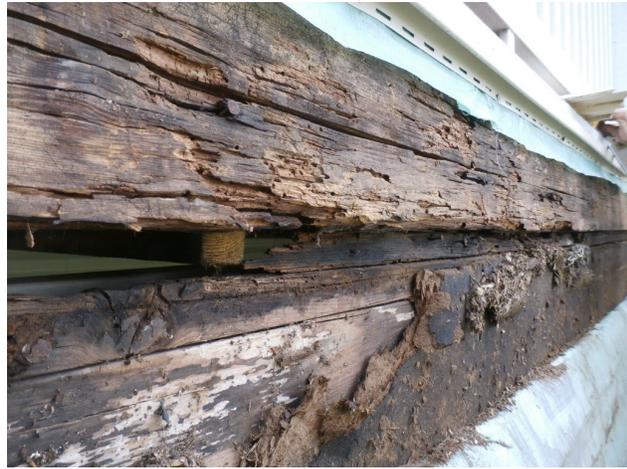
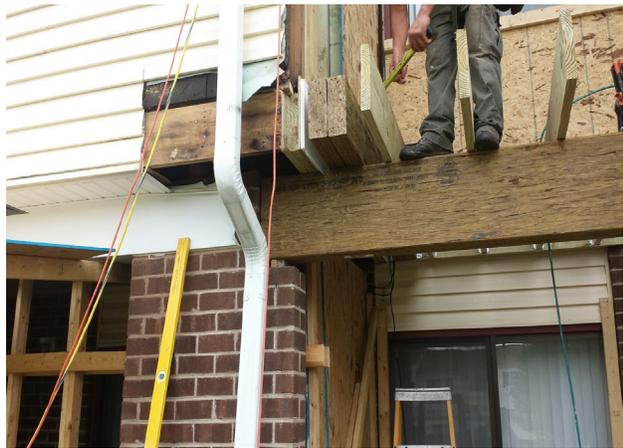
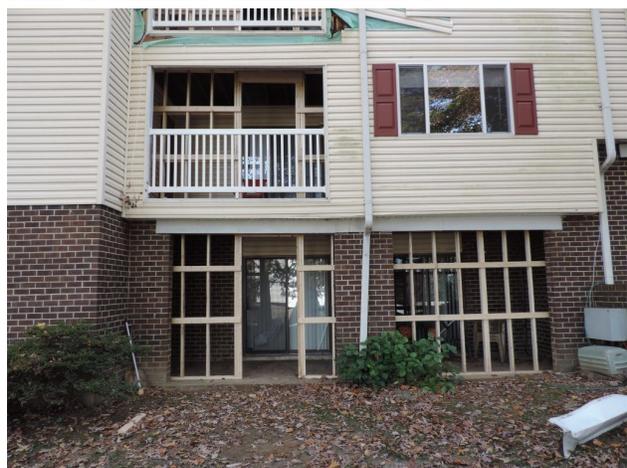
Due to failure of a wooden railing on a nearby apartment building, Baltimore County required all properties with wooden railings to be inspected by a “Third Party” expert. Davidson & Assoc. inspected the subject property and found that the vinyl railing system did not provide the required protection and that the beams supporting the floor joists were in various stages of decay. Total replacement was required.

Challenge: In order to replace the beams, temporary shoring had to be designed and installed to support each balcony and the roof trusses.

Value Added: Davidson & Assoc. was able to design temporary shoring to permit the apartments to remain occupied during construction

Service performed: Design of temporary shoring, new supporting beams and railings for a 168 unit, multi-building apartment complex.
