# DAVIDSON & ASSOCIATES

## 145 – 175 Limekiln Road (Yellow Breeches Office Complex) **Forensic Analysis and Exterior Repairs**

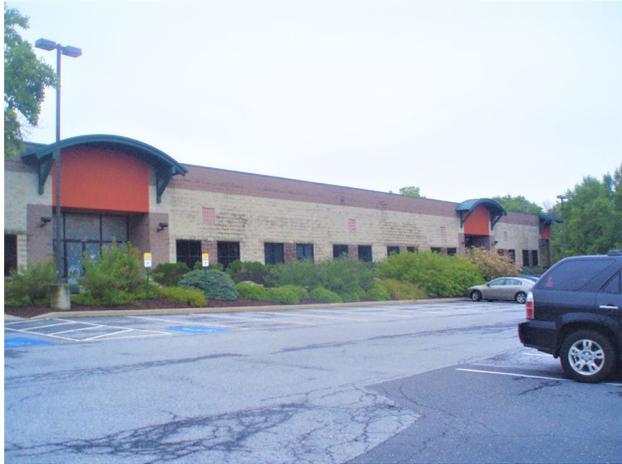
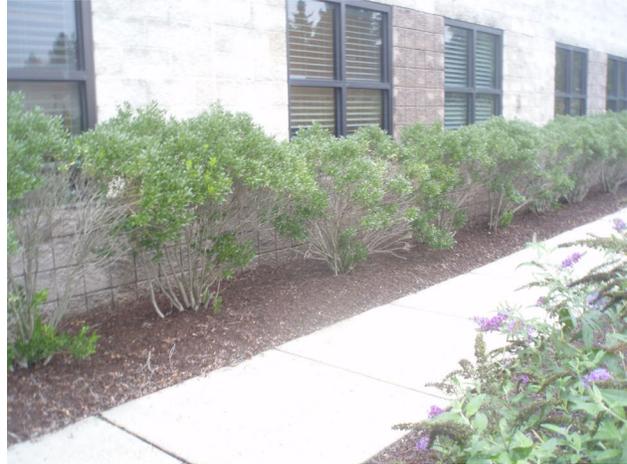
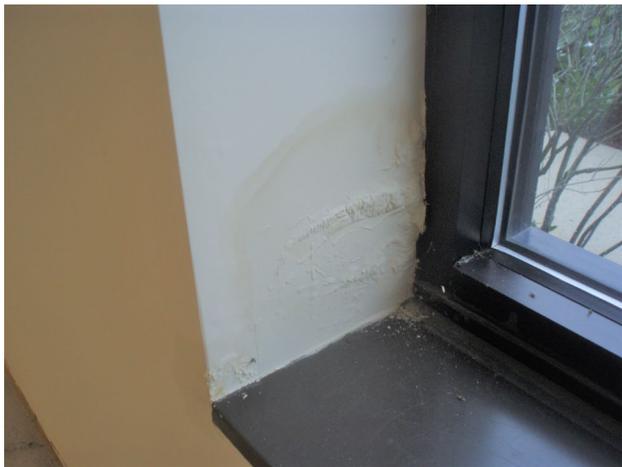
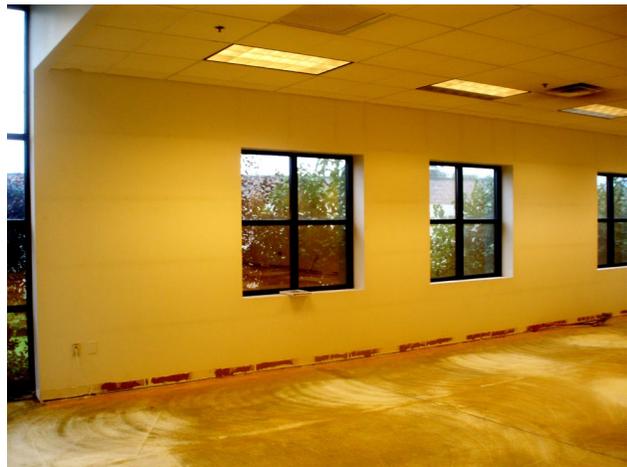
Flex office-warehouse complex composed of multiple, single-story buildings constructed circa 2001. Exterior walls are single-wythe, split- and ground-face CMU supporting steel joist roof framing protected by EPDM membrane over rigid insulation and steel deck. Building entrances and punched windows consist of aluminum frame storefront systems. The project is located in New Cumberland, PA.

**Challenge:** Owner was in the process of remodeling several vacant units within two buildings of the complex and identified water damage to interior finishes at exterior walls of office areas and visible moisture at exposed CMU surfaces within warehouse areas. Tenants also identified water infiltration, primarily at punched window openings. Thermal tracking (ghosting) was visible on gypsum board finishes at furred exterior walls.

**Value Added:** Davidson & Associates (D&A) utilized a combination of visual observations, non-destructive moisture detection and limited destructive investigation to identify window and roof flashing defects along with deferred maintenance at exterior masonry and sealant joints. Thermal modeling utilized to confirm existing conditions responsible for “ghosting”. Prioritized repair scope developed to mitigate future moisture infiltration including: window head flashing replacement, masonry repointing, sealant replacement and perimeter drainage improvements.
