Bethesda Hill Apartments Construction Document Review and Construction Monitoring

Service performed: Railing Inspection; Design new Balconies and Quality Assurance during Construction.

Product type: Rental apartments with cantilevered balconies.

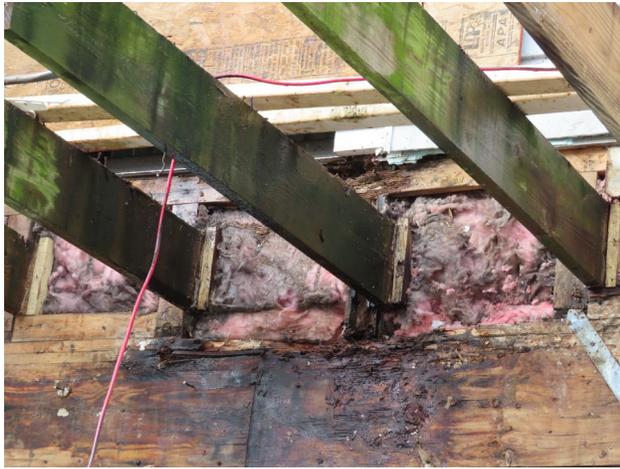
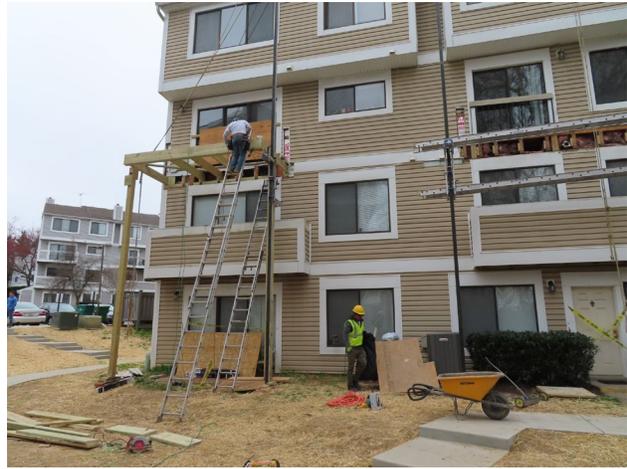
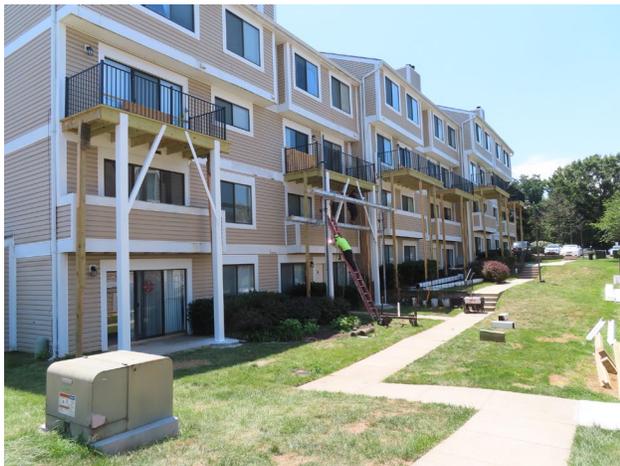
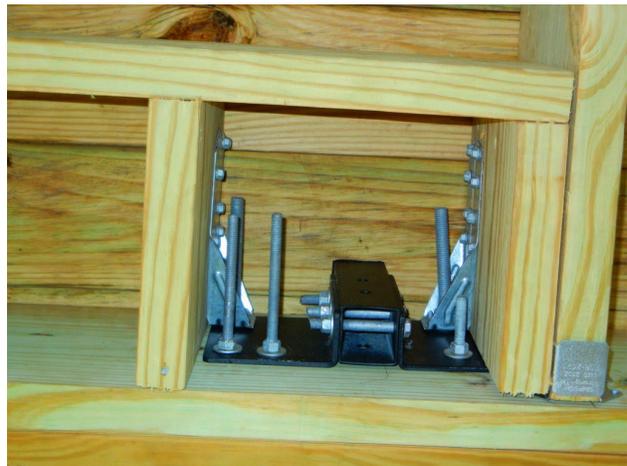
Description: The Management company was concerned that the railings were not structurally sound and hired our firm to survey the cantilevered balconies and railings.

The balconies cantilever 6' from the face of the building and are constructed of standard 2x lumber. The interior of the wood cantilever was attached to the wood floor framing and only extended 6' into the interior, half of what is required per code and good engineering practices. Thus the balconies deflected down 2". The metal railings were attached to wood knee walls which were only nailed to the balcony floors. The entire assembly required replacement.

Davidson designed new framing that was supported by the exterior walls, not relying on a cantilever. The design included flashing to prevent water from entering the building and the far end was supported by columns. The framing included tie-back framing to meet the updated building code. The property is located in Bethesda, MD.
